# KATHARINENHOF HAMBURG

## Restoration of 'Charity' window (2.8m x 1.4m) 2019

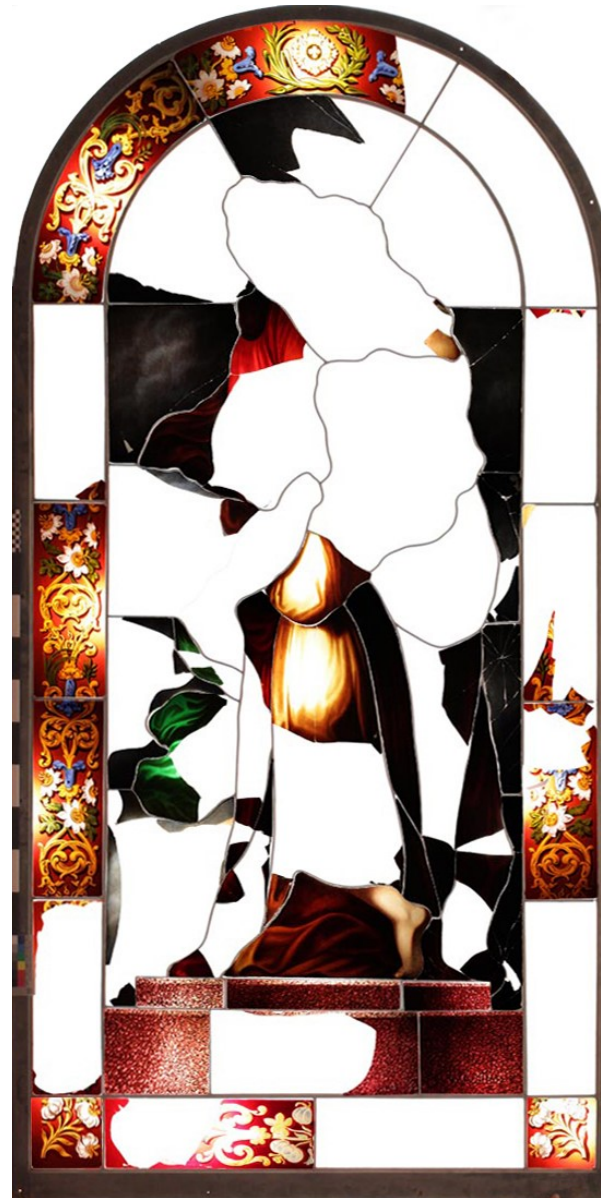
*before restoration*

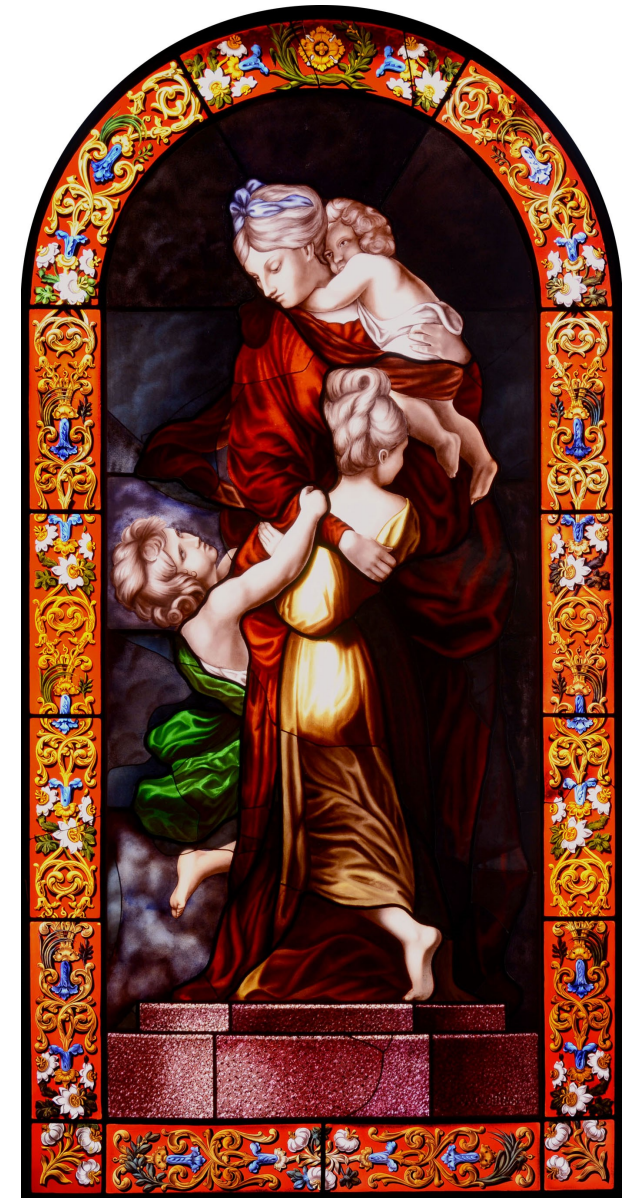
*completed window after restoration*

The 'Charity' window was brought to Barley Studio, York, UK, after initial conservation at Erfurt University. First of all, we repaired and restored the original timber, lead and iron framework, creating replica sections where necessary. We then began to re-draw the detail for missing areas of the window, based on the Reynolds cartoon and informed by the shape of the window framework which exactly followed the outlines of the figures.

We carefully studied the surviving pieces and carried out many tests to achieve a successful restoration using modern glass, pigments, stains and enamels. Each piece was fired multiple times in the kiln to fuse all of the layers of colour. Surviving original pieces of glass were incorporated into the restoration as far as possible, using copper foil to join the old to newly painted pieces.

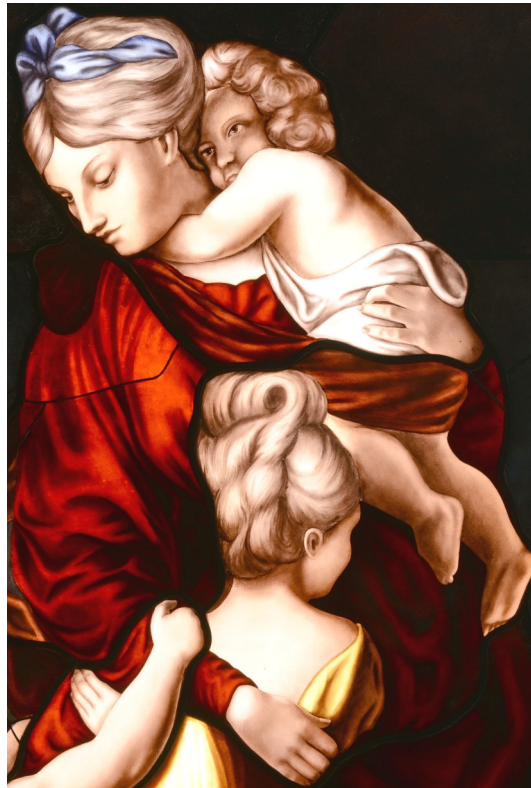
*detail of figures after restoration*

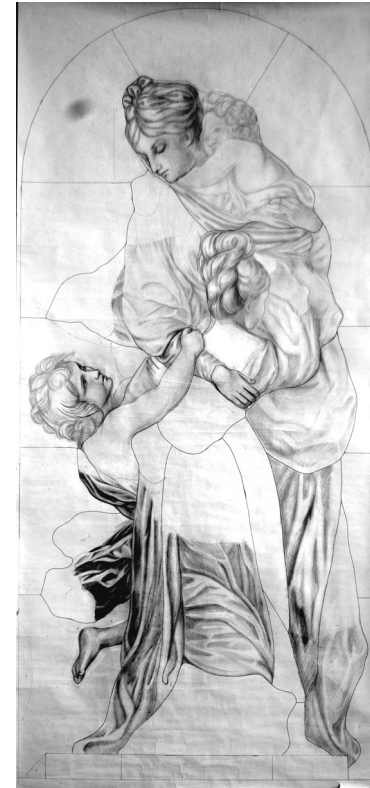
*pencil cartoon of missing areas*

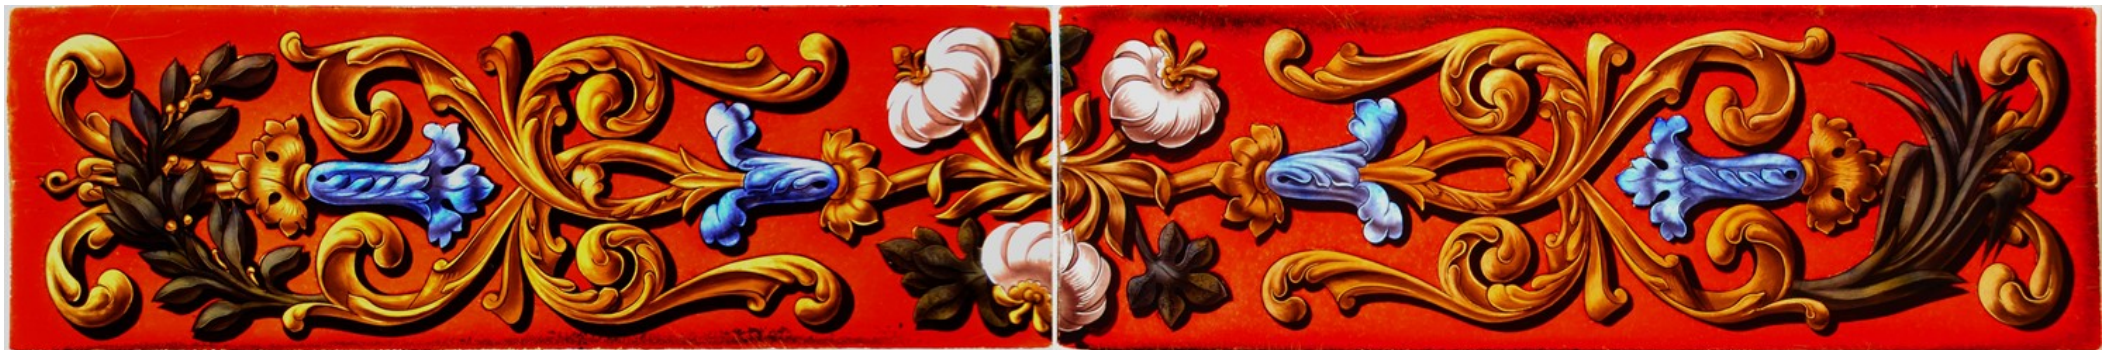
*new decorative border pieces*
