# ST DENYS' CHURCH

## WALMGATE, YORK

### Conservation and Protection of four North Nave Aisle windows 2018

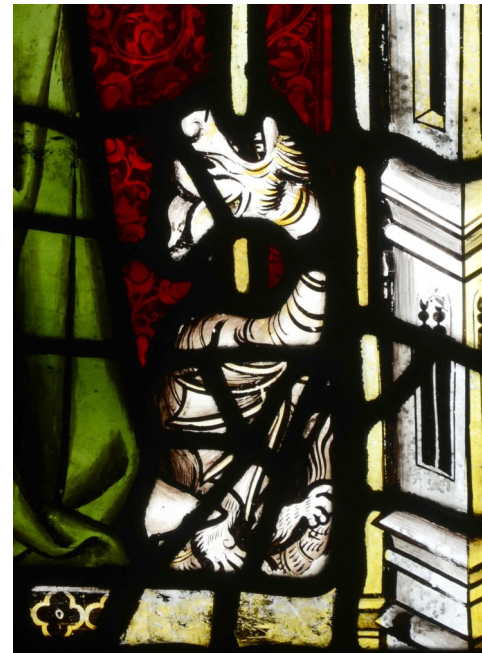
*Detail, window nIV: before conservation, with disfiguring mending leads*

The three windows of the North wall originally formed an ensemble of the same date (ca. 1340) and by the same maker, although the westernmost now contains stained glass from an early 13th-century lancet, probably the earliest stained glass surviving in the city of York. These windows were sympathetically restored by JW Knowles in the late 19th century, and were found to be generally in good condition. The glass was carefully cleaned and some aesthetic improvements made through reducing the visual intrusion of previous mending leads.

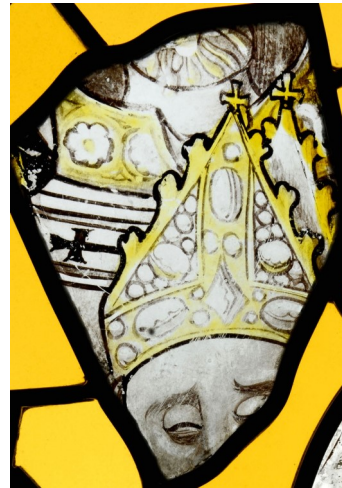
*Detail: C15th head of St Denys*

We found fourteenth-century fragments relating to medieval 'Doom' iconography, as well as later fragments including a fifteenth-century head of St Denys himself (complete with bleeding neck following his decapitation). Our new arrangement means that these delightful fragments can be viewed at close quarters for the first time in many centuries.

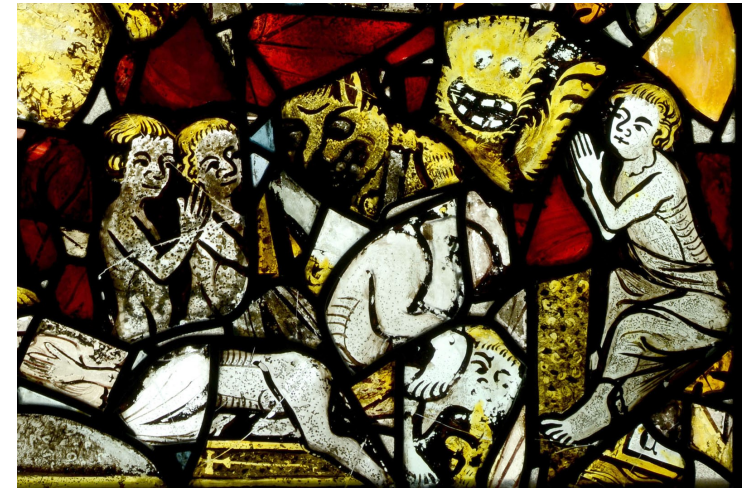
*Detail: Fragments from C14th 'Doom' iconography*
